Manhole Inspection Summary

Manhole # S25EE1026MH

Location Address: **3907 CROWTHER ST**

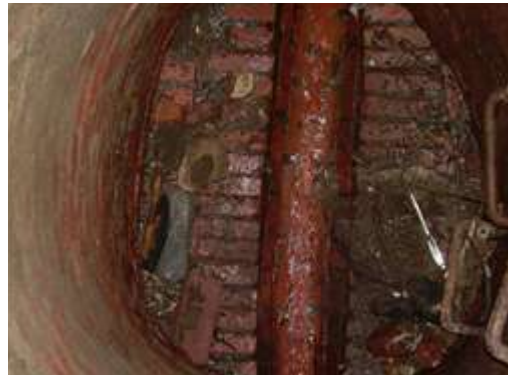
Top View

Corroded steps. Bench debris.

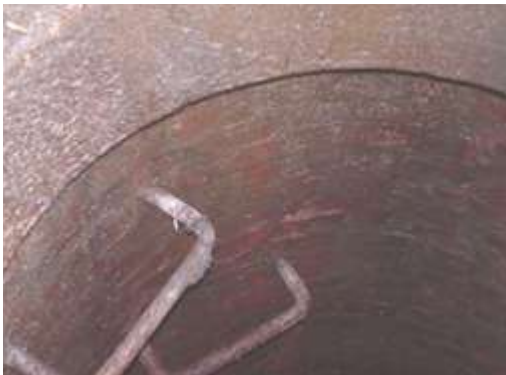
Defect

Frame leaks. Adjustment infiltration.

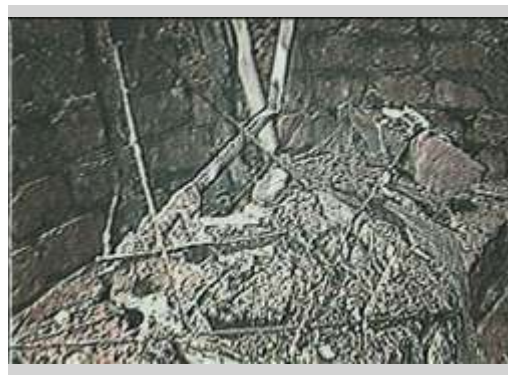
Defect

Barrel deterioration and infiltration. Bench debris.

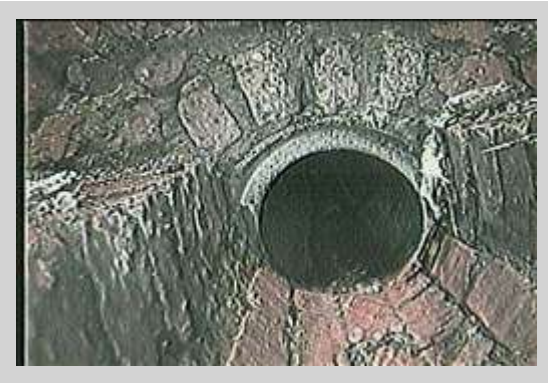
Pipe Out @ 12 O'Clock

Channel deterioration.

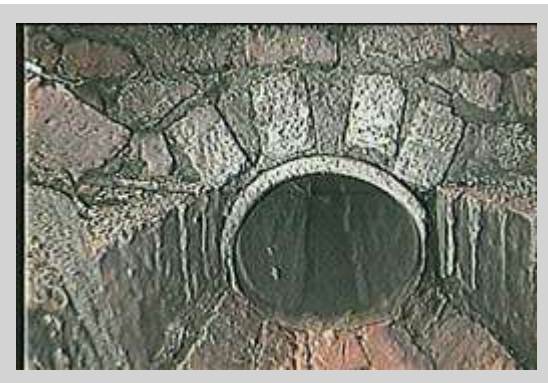
Pipe In @ 6 O'Clock

Infiltration: **Evidence** Pipe Seal Cond: **Unknown**
